SUCCESSFUL GP III FPSO MOORING CHAIN INSPECTION WITHOUT INTERRUPTION OF PRODUCTION

PROJECT OVERVIEW

In September 2021, InterMoor, the lead brand within Acteon's Moorings and Anchors segment, completed the mooring chain inspection campaign for the Global Producer III (GP3) Floating Production Storage and Offloading vessel (FPSO), on behalf of NEO Energy. The GP3 mooring system consists of ten mooring lines composed of 108mm chain and is located on the Dumbarton field in UKCS Block 15/20 in a water depth of approximately 145m.

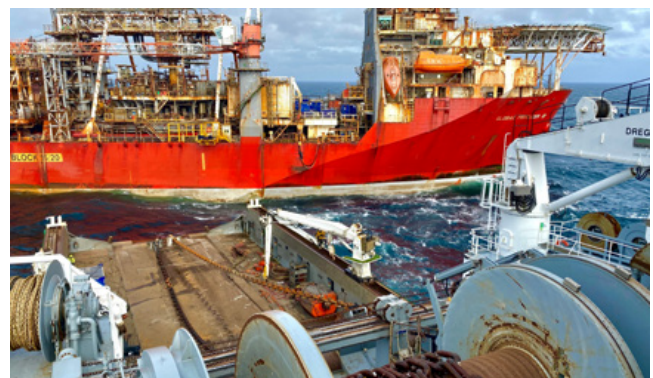
With limited available chain payout from the FPSO, as much of the top chain was inspected on the AHV where the operation was more efficient, before passing back the unrecoverable length to the FPSO for remaining inspection by InterMoor's inspectors on board.

Following detailed inspection, chain replacement activities were performed. Our offshore engineers calculated specific positions and lengths of replacement chains to limit the number of Long-Term Mooring (LTM) connectors added to the mooring catenary, minimise any additional connectors in the system, and ensure that non-LTM connectors were positioned within the FPSO chain lockers out of the load path.
