ABRASIVE SEVERANCE SERVICES FOR SLANT AND VERTICAL PLATFORM WELL ABANDONMENTS

The provision of well abrasive severance services at extreme angles by Claxton for slant and vertical platform well abandonments may be a 'first' in the UK for decommissioning.

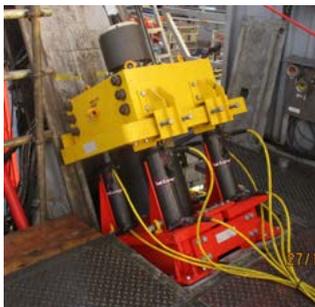
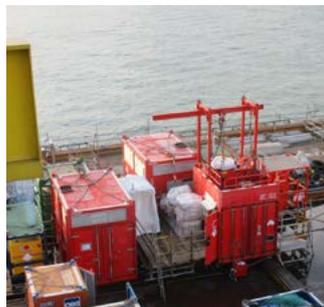
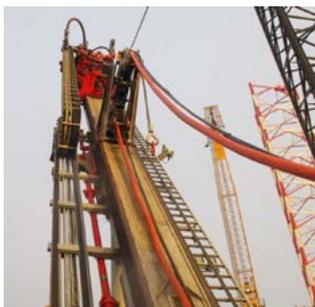
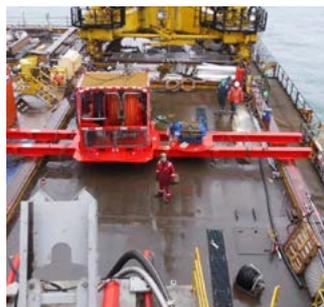
Four out of the six wells on the DP4 platform had been drilled at 30° angles and compounding the problem was the fact that the rig that had originally drilled them no longer existed, making the task a particularly challenging one for all.

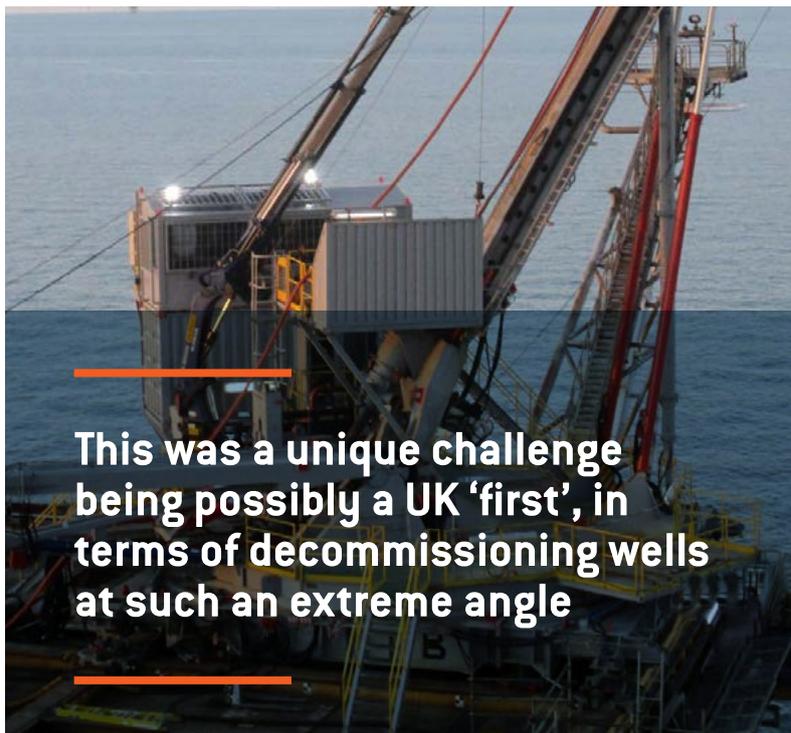
As is often the case for Claxton, much proactive consideration was given to the bespoke equipment required to enable the SABRE™ abrasive severance tool to be run in hole.

Consequently, a new proving system, sheave and support frame were manufactured and tested to accompany the innovative SABRE suite to cut and prove each well.

This was a unique challenge being possibly a UK 'first', in terms of decommissioning wells at such an extreme angle
